## Trus Joist® TJI® Joist Repair Details for Holes Located Within 12" of End Bearing

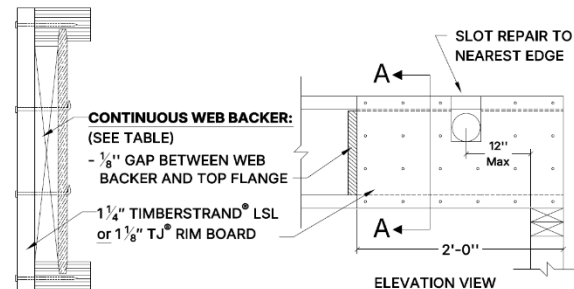
Figure 1: Repair detail for holes located within 12" of end bearing.

The repair option in Figure 1 is not valid for any of the following conditions.

Hole can not overlap inside face of bearing

Hole must only be located in web—do not cut flange

Uniform loads only—no offset bearing walls

- REPAIR MAY BE INSTALLED ON EITHER SIDE OF TJI® JOIST
- APPLY CONSTRUCTION ADHESIVE TO ALL CONTACT SURFACES
- MINIMUM BEARING LENGTH OF 2.25"

[1] Locate flange nail at center of flange.

[2] Locate web nail evenly spaced between flanges; clinch when possible.
