Trus Joist® TJI® Joist Repair Details for Holes Located Within 12" of End Bearing

Alternative Solutions Outside the Scope of TB-817

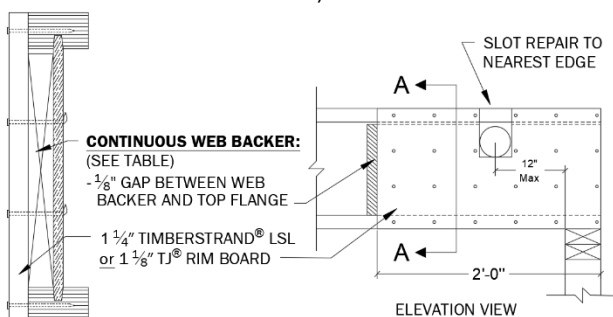
Figure 1: Repair detail for holes located within 12" of end bearing.

To ensure optimal performance of TJI® joists, web holes in TJI® joists should be positioned away from support locations in accordance with Weyerhaeuser literature. The table and detail below show how to repair a TJI® joist with a hole located within 12" of an end bearing and the maximum hole diameter allowed in these cases. This repair option assumes typical residential floor framing situations and is **ONLY allowed if the joist is repaired as shown and does not exceed the maximum span, o.c. spacing, and loads given in Table 1.**

- NOTES:**
- REPAIR MAY BE INSTALLED ON EITHER SIDE OF TJI® JOIST
 - APPLY CONSTRUCTION ADHESIVE TO ALL CONTACT SURFACES

[1] Locate flange nail at center of flange.
 [2] Locate web nail evenly spaced between flanges; clinch when possible.

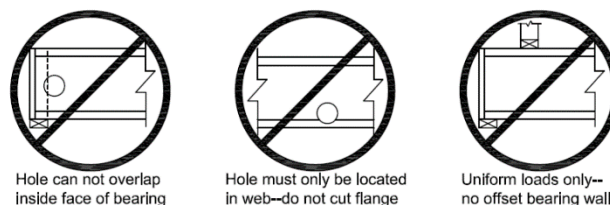
The repair option in Figure 1 is not valid for any of the following conditions.
