Trus Joist® TJI® Joist Repair Details for Holes Located Within 12" of End Bearing

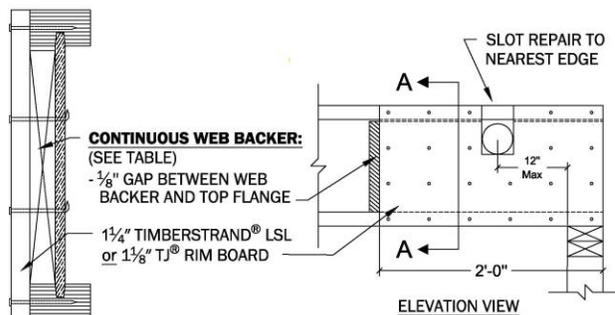
Figure 1: Repair detail for holes located within 12" of end bearing.

To ensure optimal performance of TJI® joists, web holes in TJI® joists should be positioned away from support locations in accordance with Weyerhaeuser literature. The table and detail below show how to repair a TJI® joist with a hole located within 12" of an end bearing and the maximum hole diameter allowed in these cases. This repair option assumes typical residential floor framing situations and is allowed **ONLY if the joist is repaired as shown and does not exceed the maximum span, o.c. spacing, and loads given by Table 1.**

Hole can not overlap inside face of bearing

Hole must only be located in web--do not cut flange

Uniform loads only--no offset bearing walls

- REPAIR MAY BE INSTALLED ON EITHER SIDE OF TJI® JOIST
- APPLY CONSTRUCTION ADHESIVE TO ALL CONTACT SURFACES
- MINIMUM BEARING LENGTH OF 2.25"

Product	Web Backer Thickness	Flange Nail ^[1]	Web Nail ^[2]
TJI® 110	¾" (net)	10d (0.128" x 3") @ 4" o.c.	
TJI® 210	7/8" (net)		
TJI® 230	1" (net)		
TJI® 360	1" (net)		
TJI® 560	1½" (net)	16d (0.162" x 3 ½") @ 4" o.c.

- [1] Locate Flange nail at center of flange.
- [2] Locate web nail evenly spaced between flanges; clinch when possible.
