Prevention and Repair of Floor System Squeaks

PREVENT SQUEAKS WITH A PROPERLY INSTALLED FLOOR SYSTEM

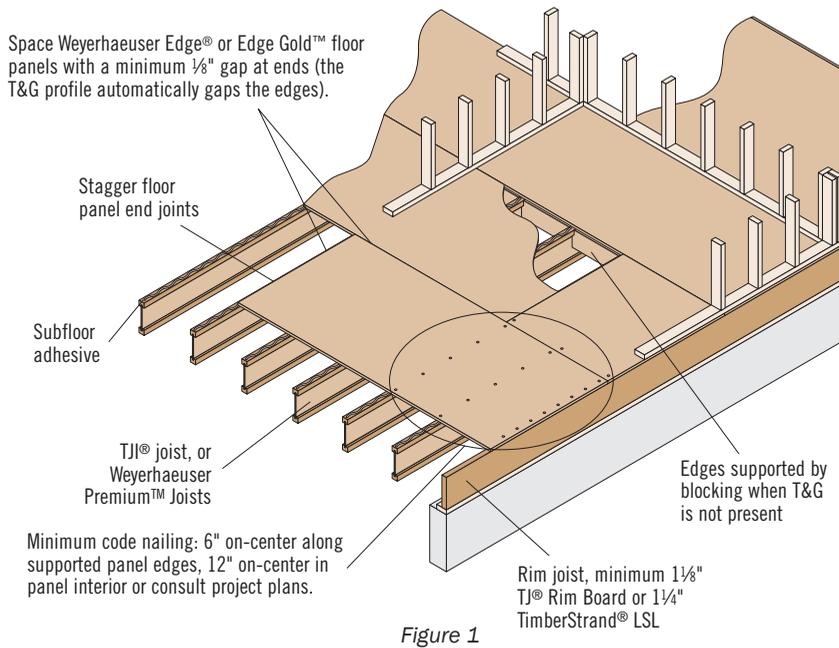
Figure 1

- Install the first panel with the tongue edge toward the perimeter. This protects the tongues on the remaining panels from damage when they are slid into place.
- Panels are sized to accommodate a $\frac{1}{8}$ " space between all joints (including the self-gapping T&G) to allow for panel expansion. Stagger panel ends in each succeeding row.

Space panels with a $\frac{1}{8}$ " gap at all edges and ends. See *Figure 1* on page 2. Weyerhaeuser Edge® and Edge Gold™ oriented strand board (OSB) flooring panels have tongue-and-groove (T&G) edges on the long sides that automatically provide the required spacing. Do not force a tight fit of the tongue into the groove. See *Figure 3*. This allows room for the panels to expand with ambient moisture conditions. Also make sure the panels are acclimated before installing. Doing this will minimize the chance for panel buckling.

floor joists. This will help avoid nail pops, pullouts, and shiners (nails that barely hit the joist) that can cause squeaks in the floor system. See *Figure 1* on page 2 for code minimum nailing and installation procedures.

Alternatively, install blocking per *Figure 1* on page 2, or use adhesive and screws to attach panel blocking flat to the underside of the joint. See *Figure 12*.

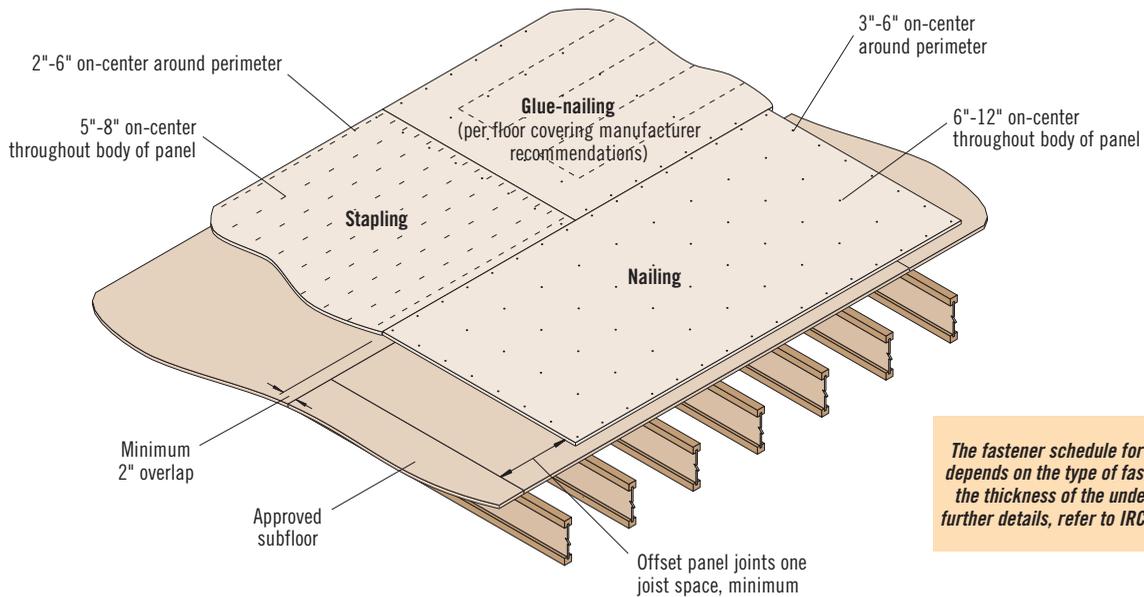
Figure 20

The fastener schedule for underlayment depends on the type of fastener used and the thickness of the underlayment. For further details, refer to IRC Table 602.3(2).

Make sure the subfloor is clean before installing underlayment. Use the recommended nails and fastening schedules, and consider applying underlayment adhesive. See *Figure 20*. Check with the floor covering manufacturer for a recommended underlayment adhesive.
